TAMU Project

**Energy Consumption Data Quality Assurance/Quality
Control Assessment Report for the
Month of September 2016**

**Utility & Energy Services
Division of Administration
Texas A&M University**

October 2016

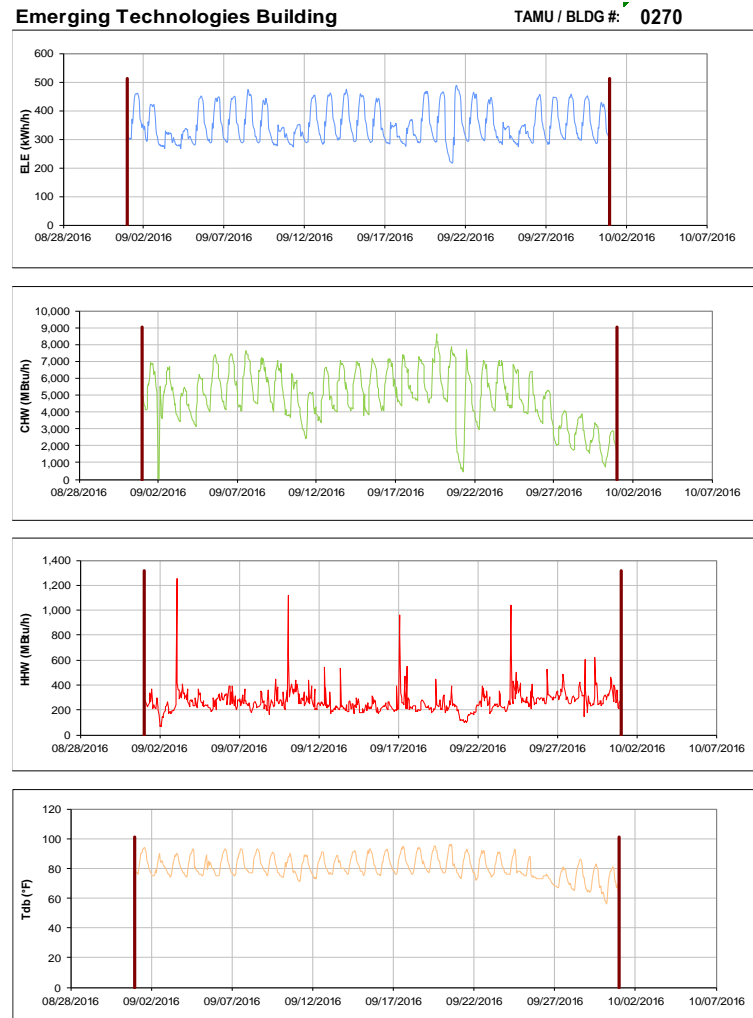
Figure III-1 Hourly Whole Building Electricity, Chilled Water, and Hot Water Consumption for Emerging Technologies Building during the Month of September 2016 and the Corresponding Hourly Outdoor Dry Bulb Temperature for College Station, TX

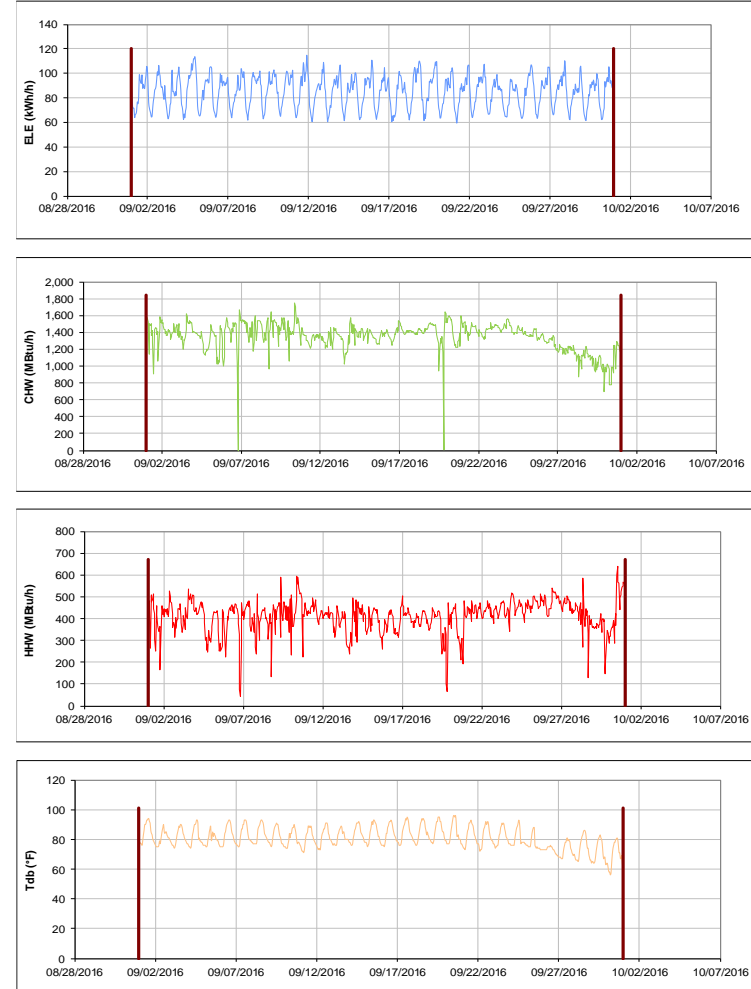
TAMU / BLDG #: 0293

Figure III-6 Hourly Whole Building Electricity, Chilled Water, and Hot Water Consumption for Appelt Residence Hall during the Month of September 2016 and the Corresponding Hourly Outdoor Dry Bulb Temperature for College Station, TX

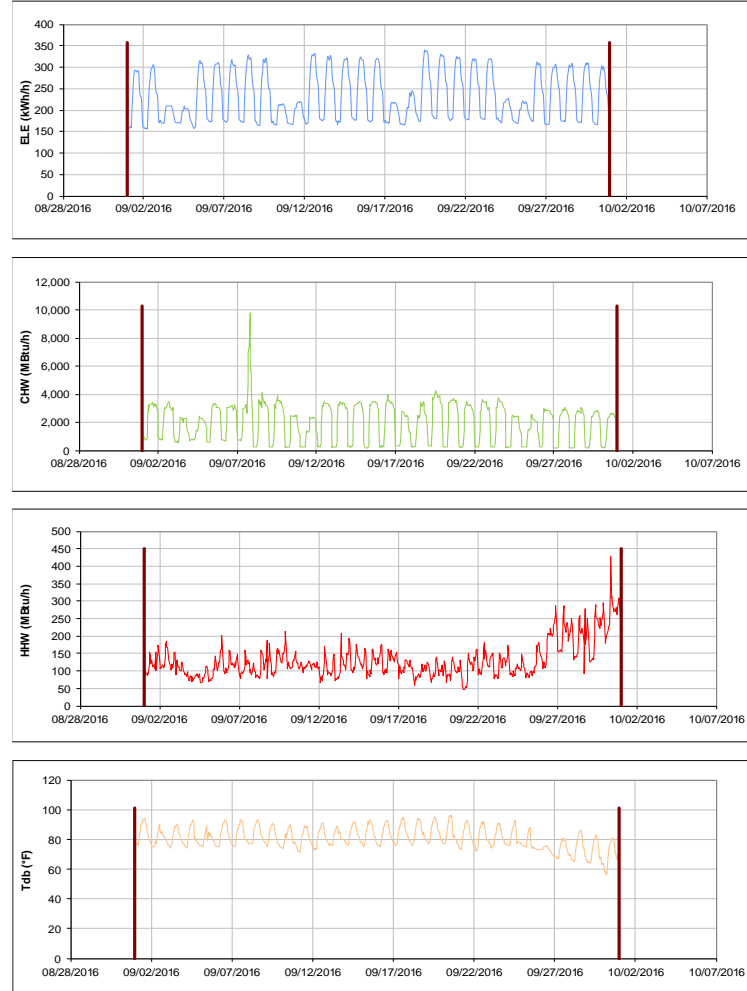
TAMU / BLDG #: 1325-0385

Figure III-9 Hourly Whole Building Electricity, Chilled Water, and Hot Water Consumption for CE TTI Office & Lab Building during the Month of September 2016 and the Corresponding Hourly Outdoor Dry Bulb Temperature for College Station, TX

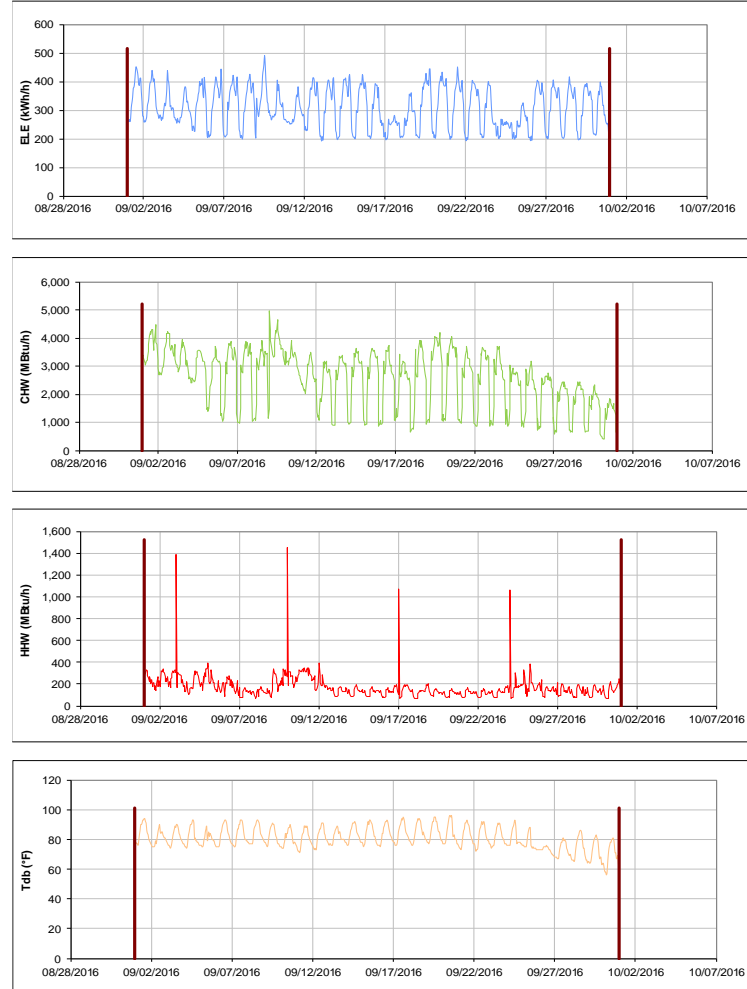
TAMU / BLDG #: 0361

Figure III-15 Hourly Whole Building Electricity, Chilled Water, and Hot Water Consumption for Bright Football Complex during the Month of September 2016 and the Corresponding Hourly Outdoor Dry Bulb Temperature for College Station, TX

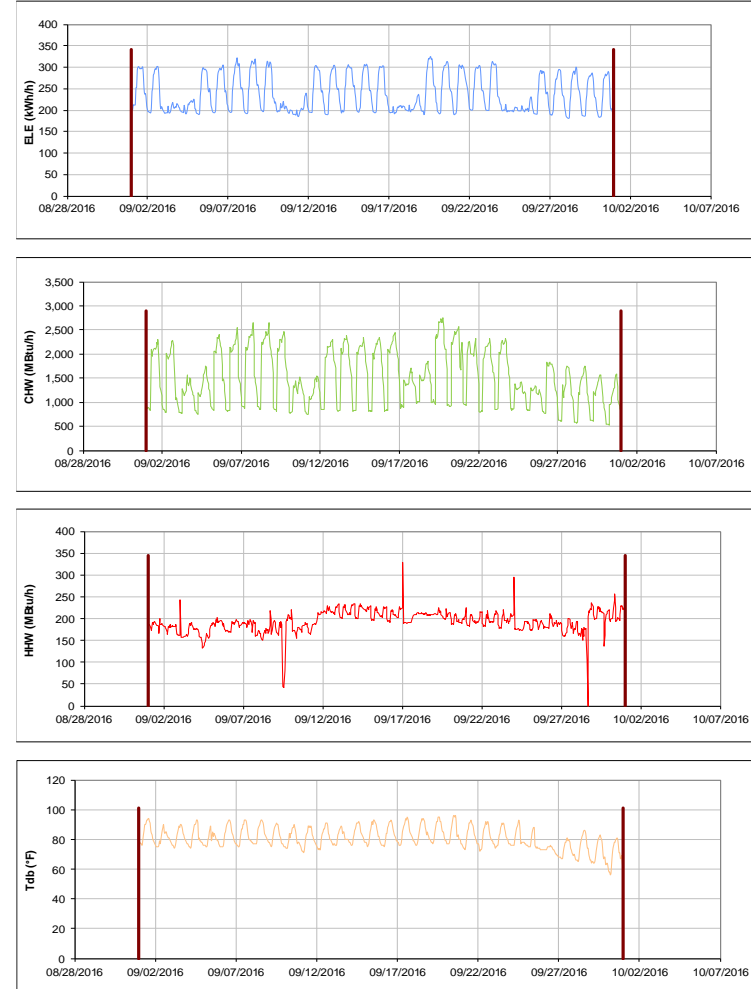
TAMU / BLDG #: 0383

Figure III-18 Hourly Whole Building Electricity, Chilled Water, and Hot Water Consumption for Koldus Building during the Month of September 2016 and the Corresponding Hourly Outdoor Dry Bulb Temperature for College Station, TX

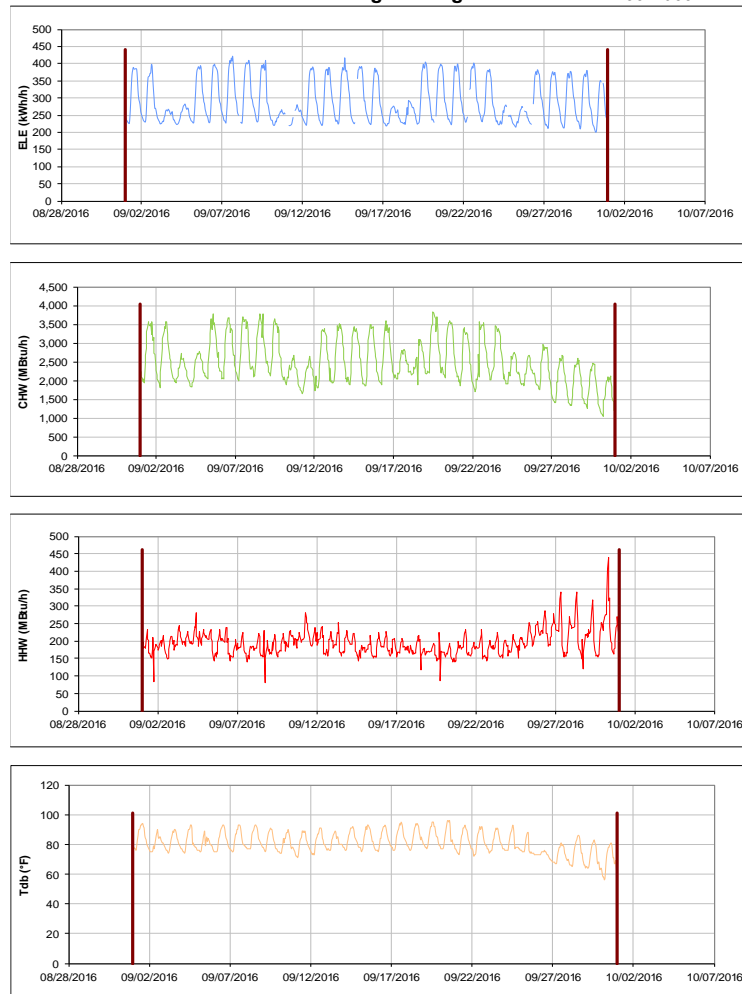
James J. Cain'51 and Mechanical Engineering Office Building TAMU / BLDG #: 1391-0392

Figure III-22 Hourly Whole Building Electricity, Chilled Water, and Hot Water Consumption for James J. Cain'51 and Mechanical Engineering Office Building during the Month of September 2016 and the Corresponding Hourly Outdoor Dry Bulb Temperature for College Station,

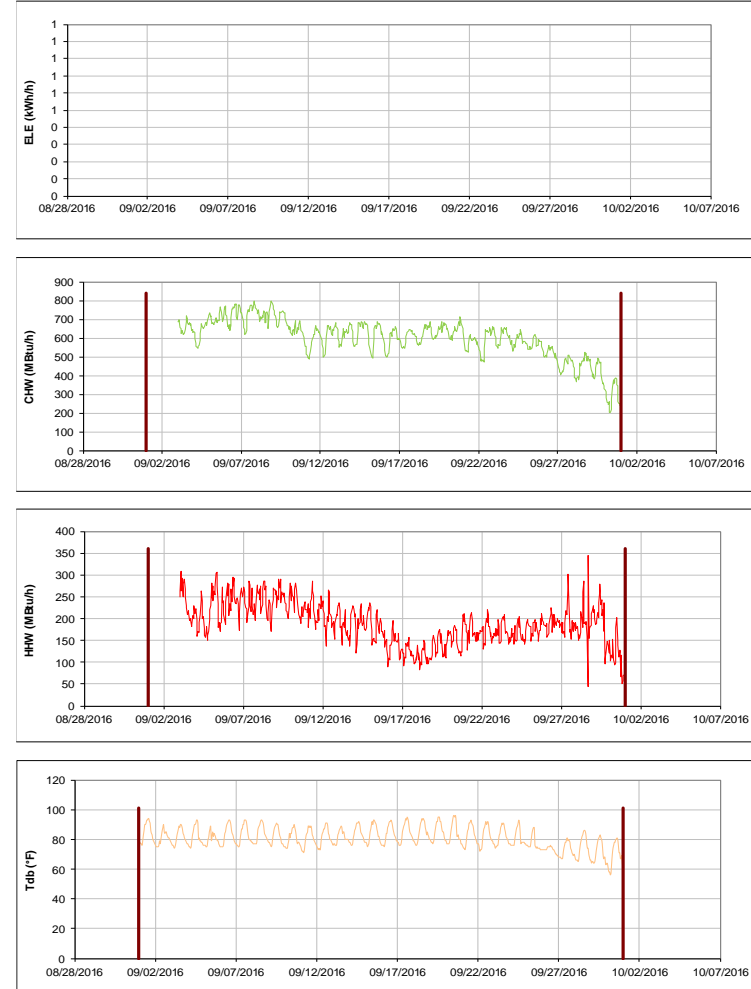
TAMU / BLDG #: 1405

Figure III-28 Hourly Whole Building Electricity, Chilled Water, and Hot Water Consumption for Ash II LLC during the Month of September 2016 and the Corresponding Hourly Outdoor Dry Bulb Temperature for College Station, TX

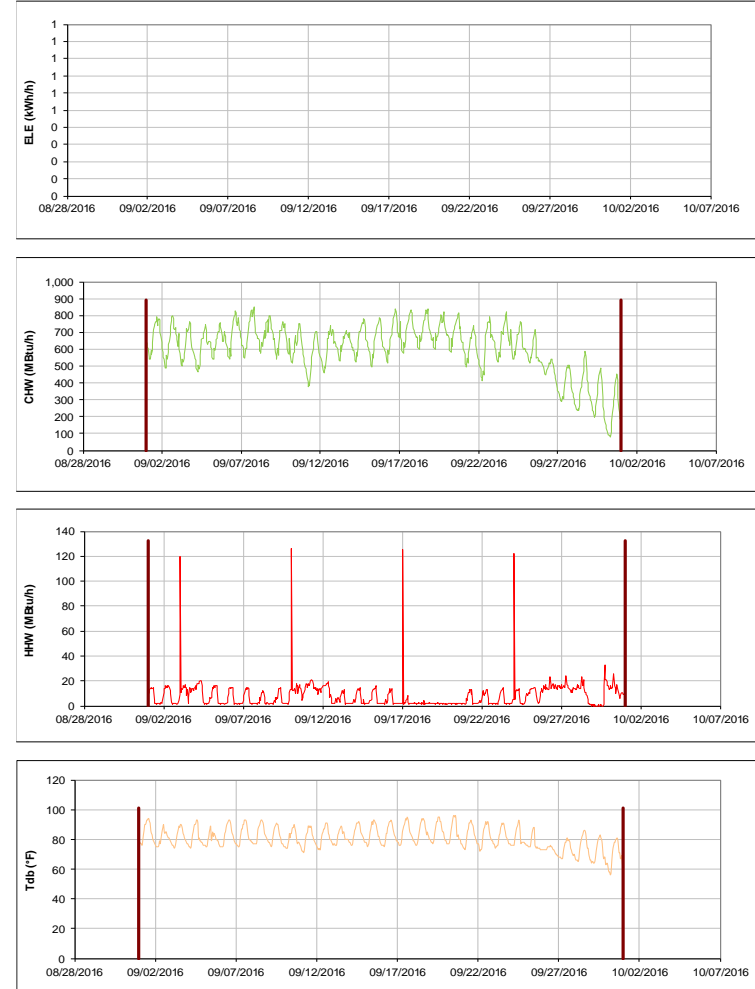
TAMU / BLDG #: 1402

Figure III-40 Hourly Whole Building Electricity, Chilled Water, and Hot Water Consumption for Buzbee Leadership Learning Center during the Month of September 2016 and the Corresponding Hourly Outdoor Dry Bulb Temperature for College Station, TX

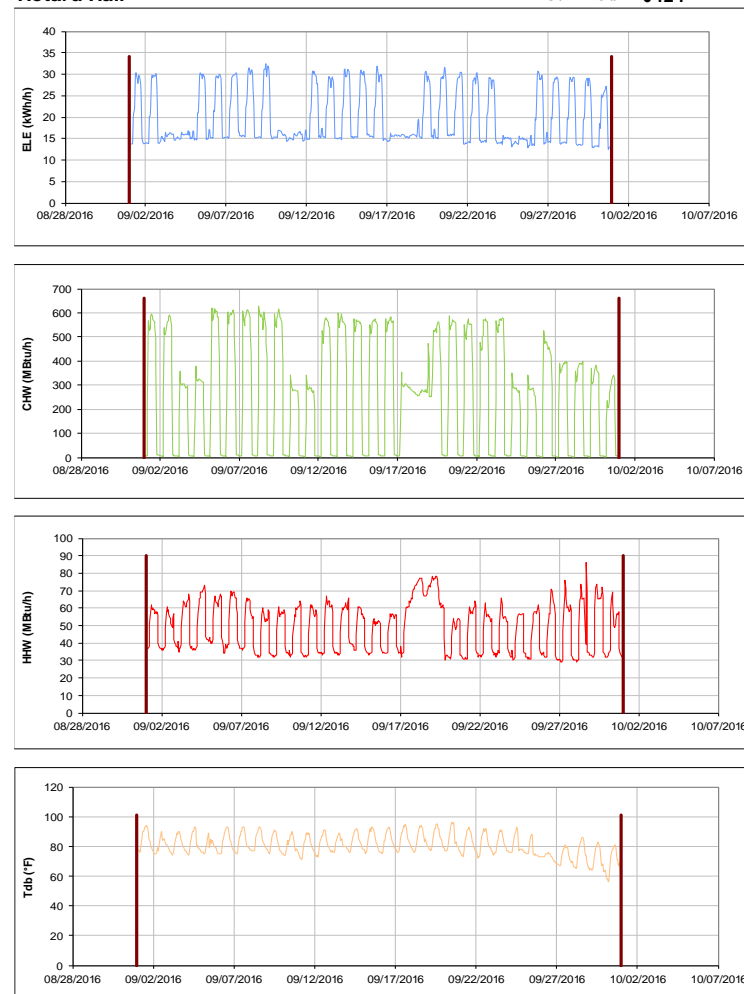
TAMU / BLDG #: 0424

Figure III-46 Hourly Whole Building Electricity, Chilled Water, and Hot Water Consumption for Hotard Hall during the Month of September 2016 and the Corresponding Hourly Outdoor Dry Bulb Temperature for College Station, TX

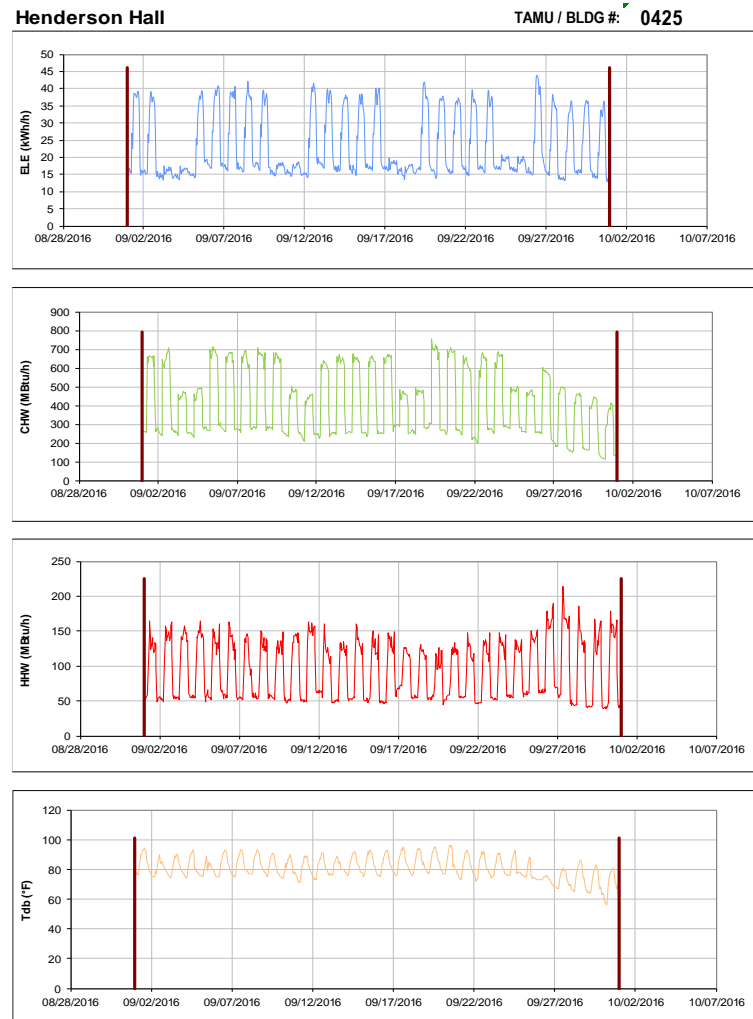
Figure III-47 Hourly Whole Building Electricity, Chilled Water, and Hot Water Consumption for Henderson Hall during the Month of September 2016 and the Corresponding Hourly Outdoor Dry Bulb Temperature for College Station, TX

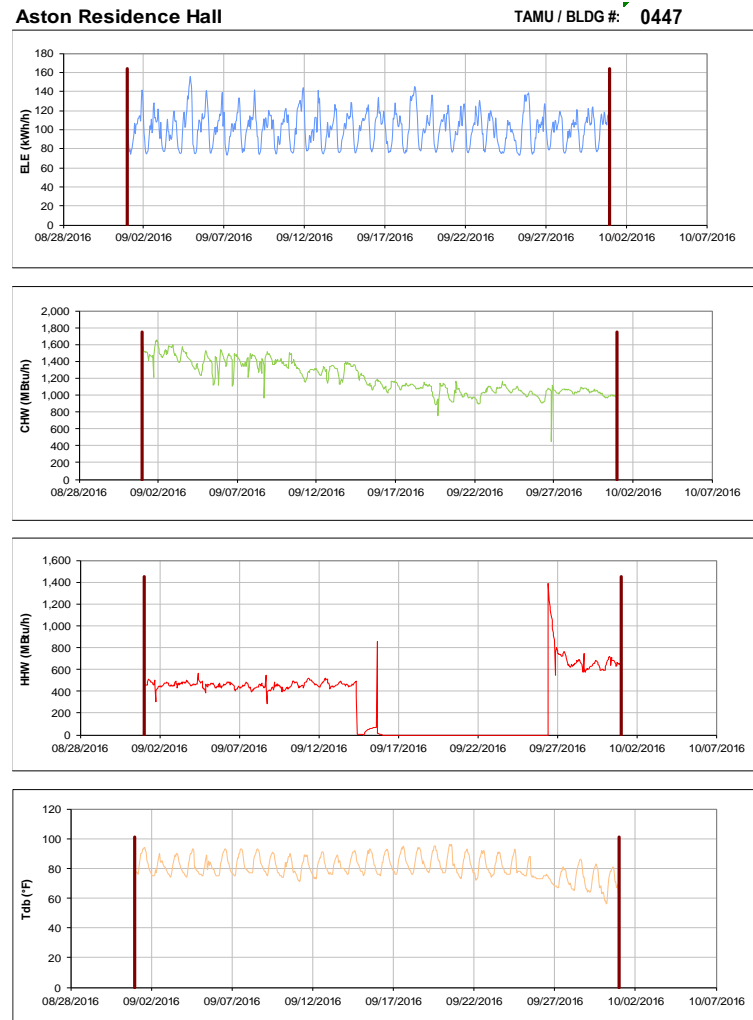
Figure III-55 Hourly Whole Building Electricity, Chilled Water, and Hot Water Consumption for Aston Residence Hall during the Month of September 2016 and the Corresponding Hourly Outdoor Dry Bulb Temperature for College Station, TX

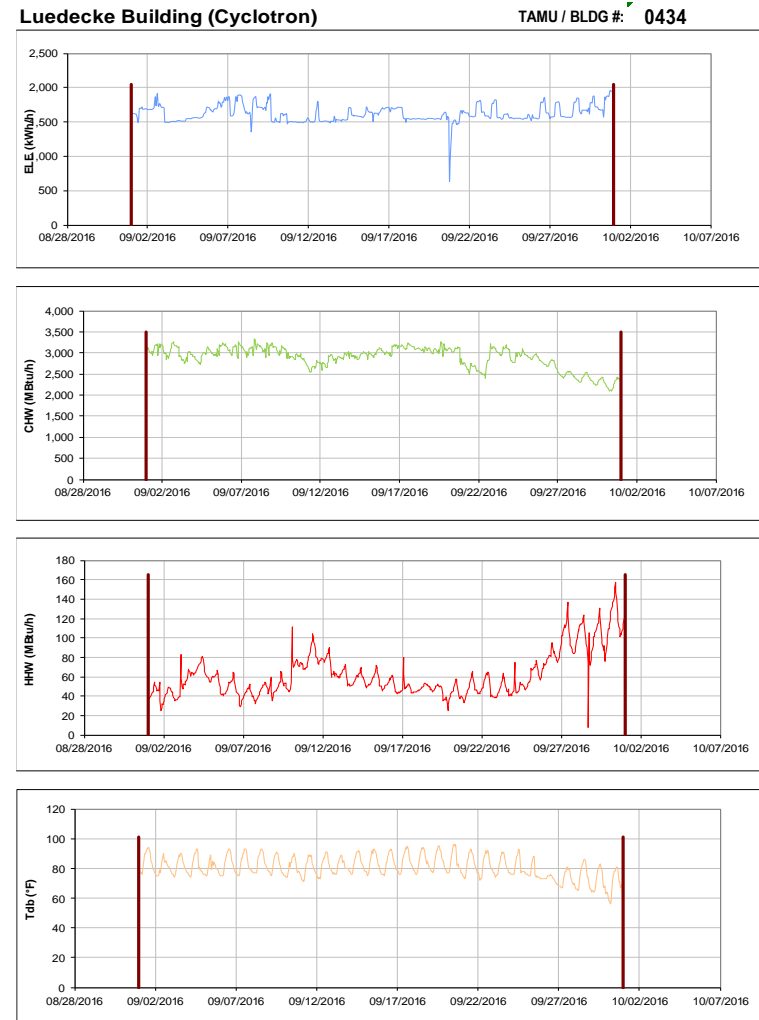
Figure III-56 Hourly Whole Building Electricity, Chilled Water, and Hot Water Consumption for Luedecke Building (Cyclotron) during the Month of September 2016 and the Corresponding Hourly Outdoor Dry Bulb Temperature for College Station, TX

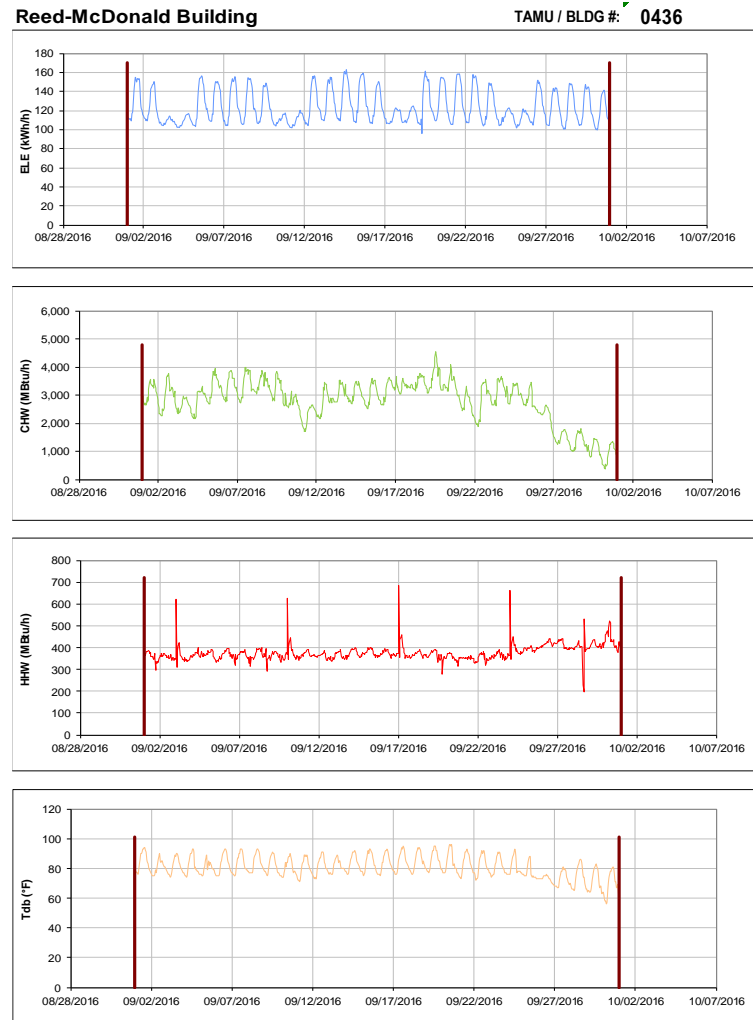
Figure III-59 Hourly Whole Building Electricity, Chilled Water, and Hot Water Consumption for Reed-McDonald Building during the Month of September 2016 and the Corresponding Hourly Outdoor Dry Bulb Temperature for College Station, TX

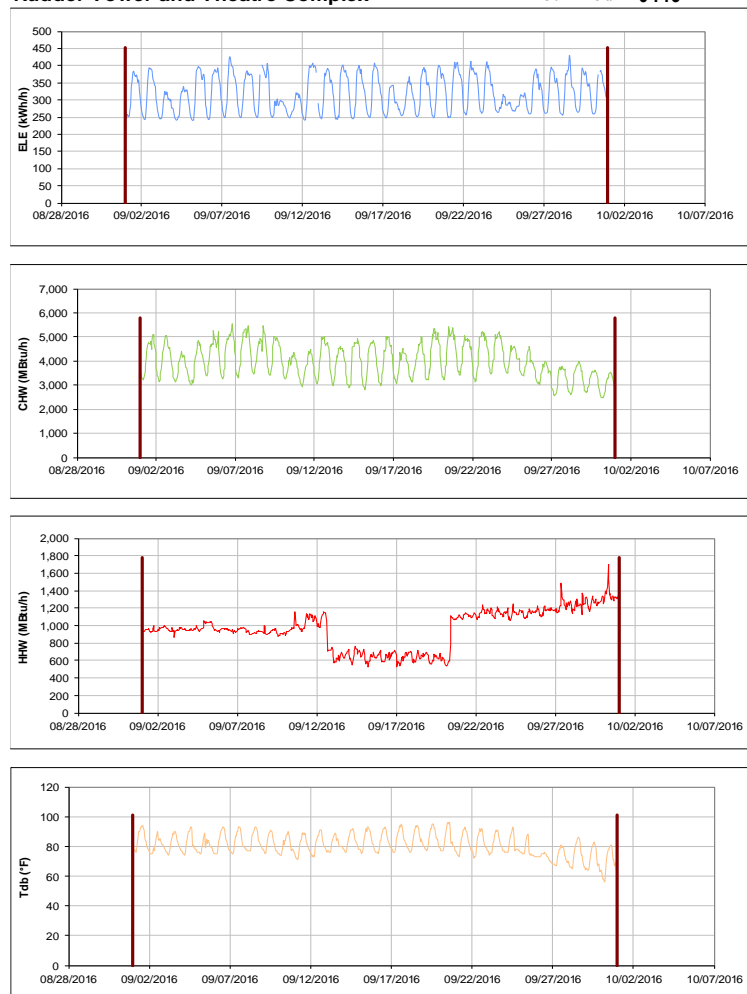
TAMU / BLDG #: 0446

Figure III-67 Hourly Whole Building Electricity, Chilled Water, and Hot Water Consumption for Rudder Tower and Theatre Complex during the Month of September 2016 and the Corresponding Hourly Outdoor Dry Bulb Temperature for College Station, TX

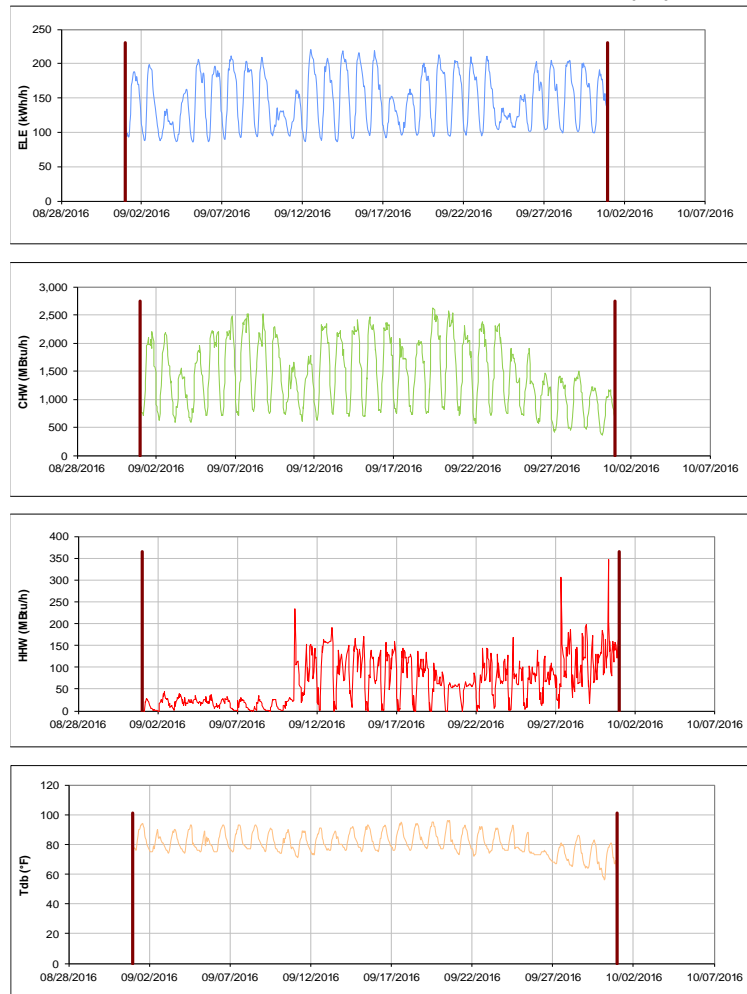
TAMU / BLDG #: 0446-B

Figure III-69 Hourly Whole Building Electricity, Chilled Water, and Hot Water Consumption for Rudder Tower during the Month of September 2016 and the Corresponding Hourly Outdoor Dry Bulb Temperature for College Station, TX

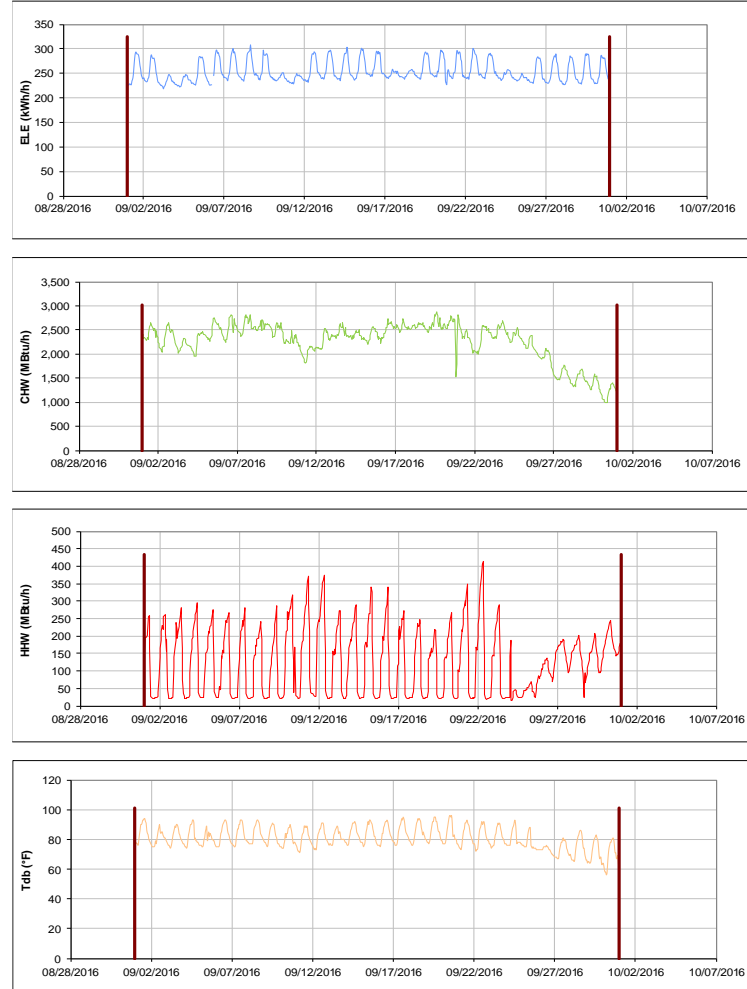
TAMU / BLDG #: 0449

Figure III-71 Hourly Whole Building Electricity, Chilled Water, and Hot Water Consumption for Biological Sciences Building - West during the Month of September 2016 and the Corresponding Hourly Outdoor Dry Bulb Temperature for College Station, TX

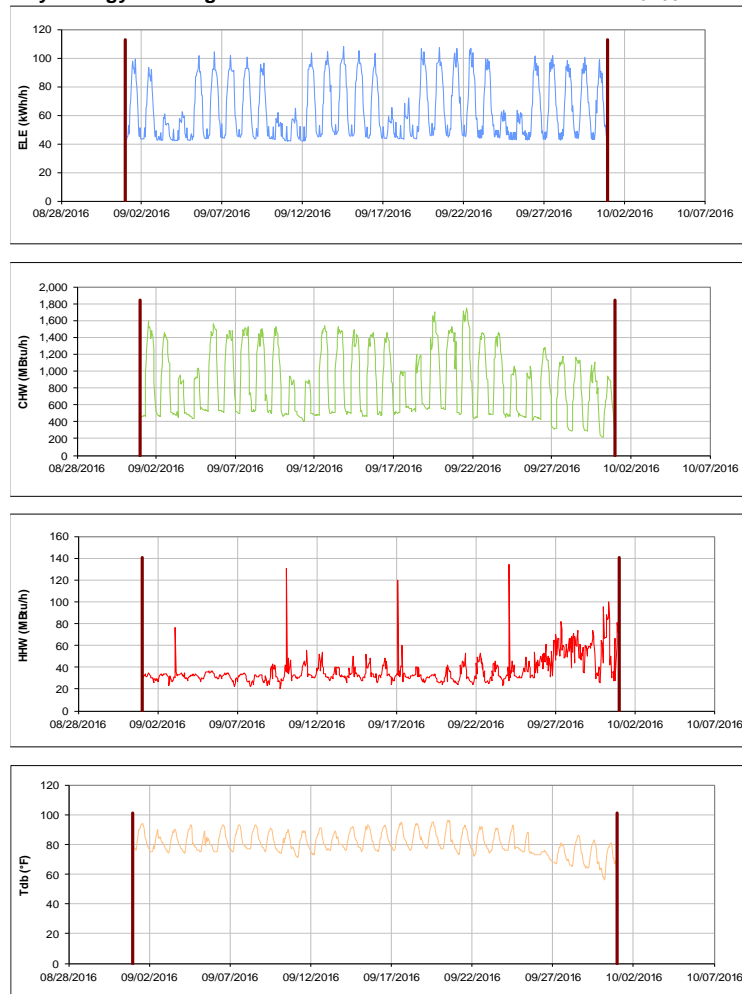
TAMU / BLDG #: 0463

Figure III-78 Hourly Whole Building Electricity, Chilled Water, and Hot Water Consumption for Psychology Building during the Month of September 2016 and the Corresponding Hourly Outdoor Dry Bulb Temperature for College Station, TX

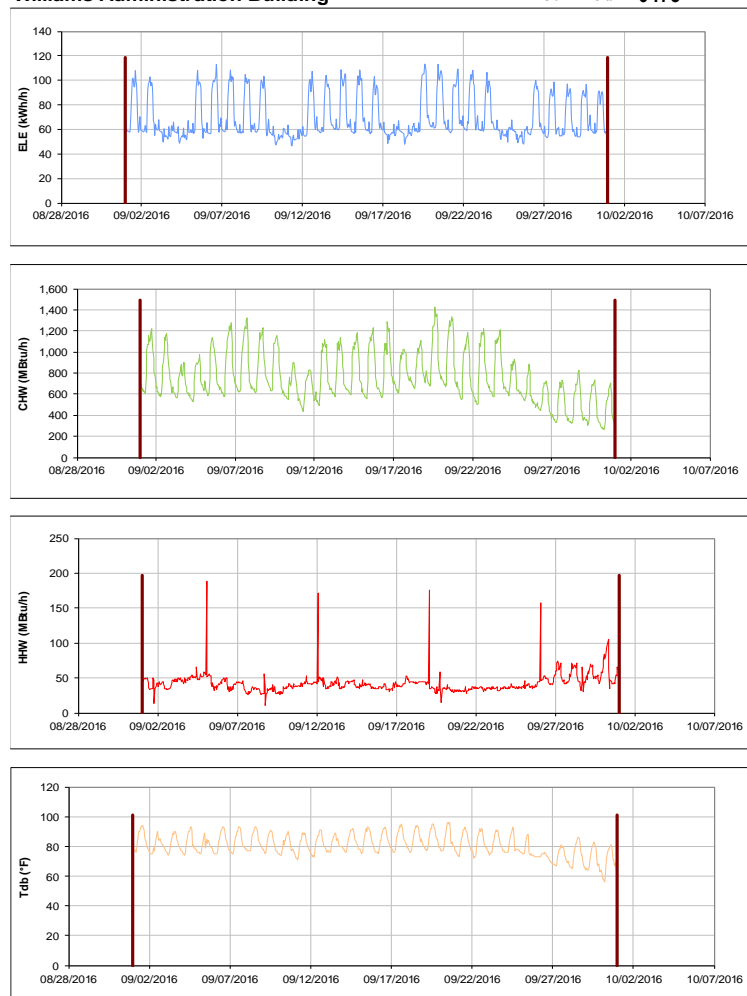
TAMU / BLDG #: 0473

Figure III-87 Hourly Whole Building Electricity, Chilled Water, and Hot Water Consumption for Williams Administration Building during the Month of September 2016 and the Corresponding Hourly Outdoor Dry Bulb Temperature for College Station, TX

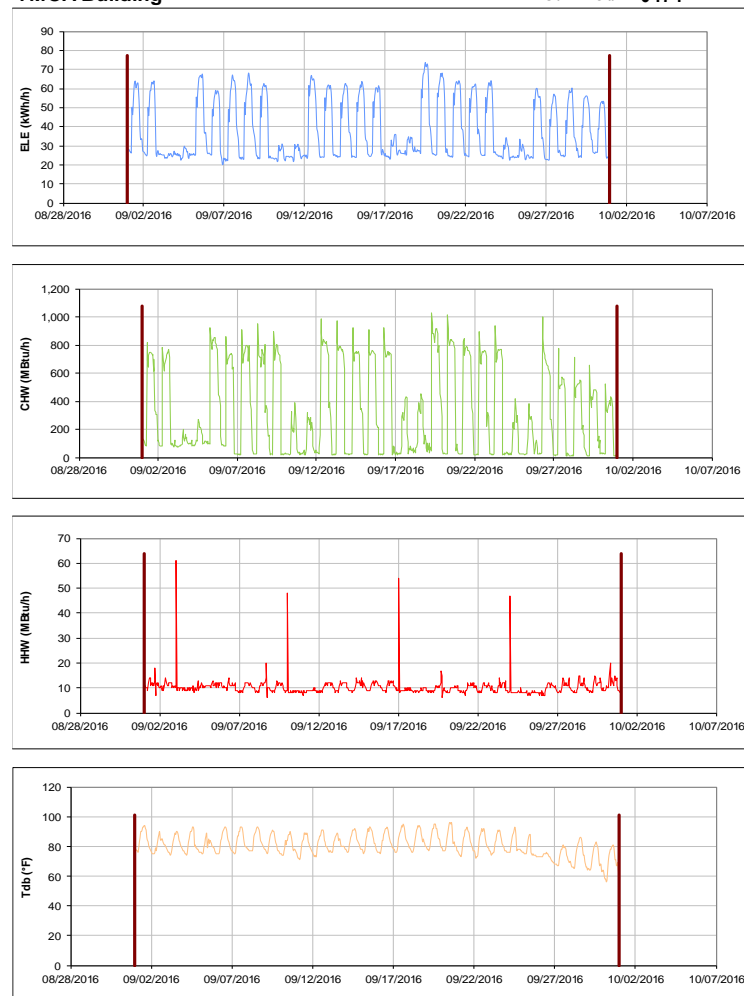
TAMU / BLDG #: 0474

Figure III-88 Hourly Whole Building Electricity, Chilled Water, and Hot Water Consumption for YMCA Building during the Month of September 2016 and the Corresponding Hourly Outdoor Dry Bulb Temperature for College Station, TX

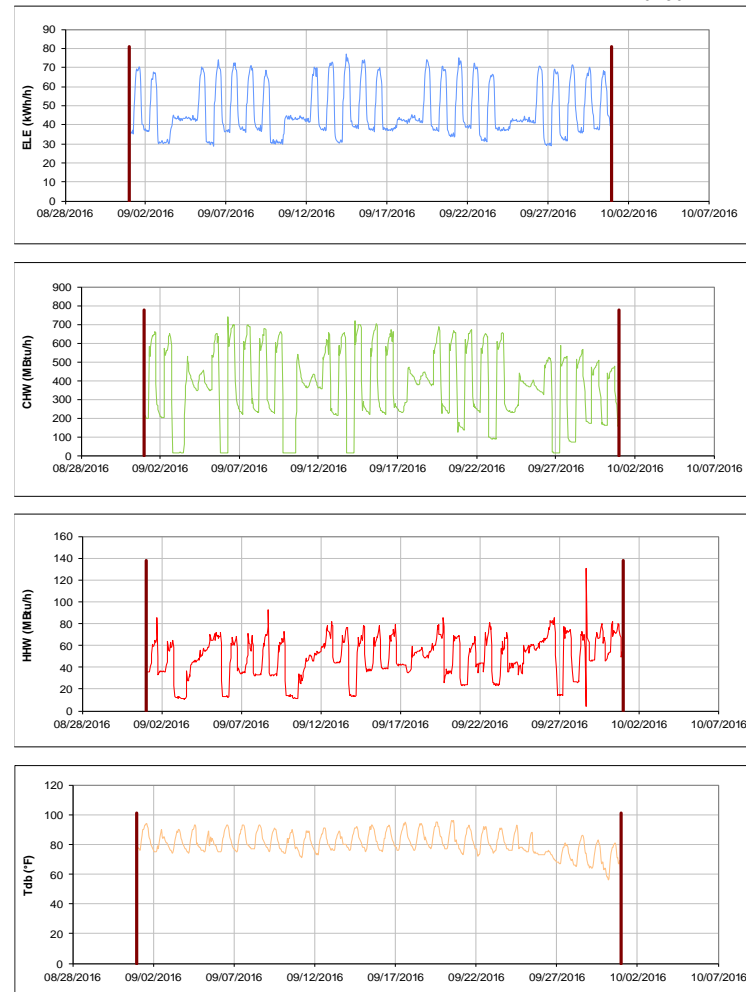
TAMU / BLDG #: 0480

Figure III-92 Hourly Whole Building Electricity, Chilled Water, and Hot Water Consumption for Bolton Hall during the Month of September 2016 and the Corresponding Hourly Outdoor Dry Bulb Temperature for College Station, TX

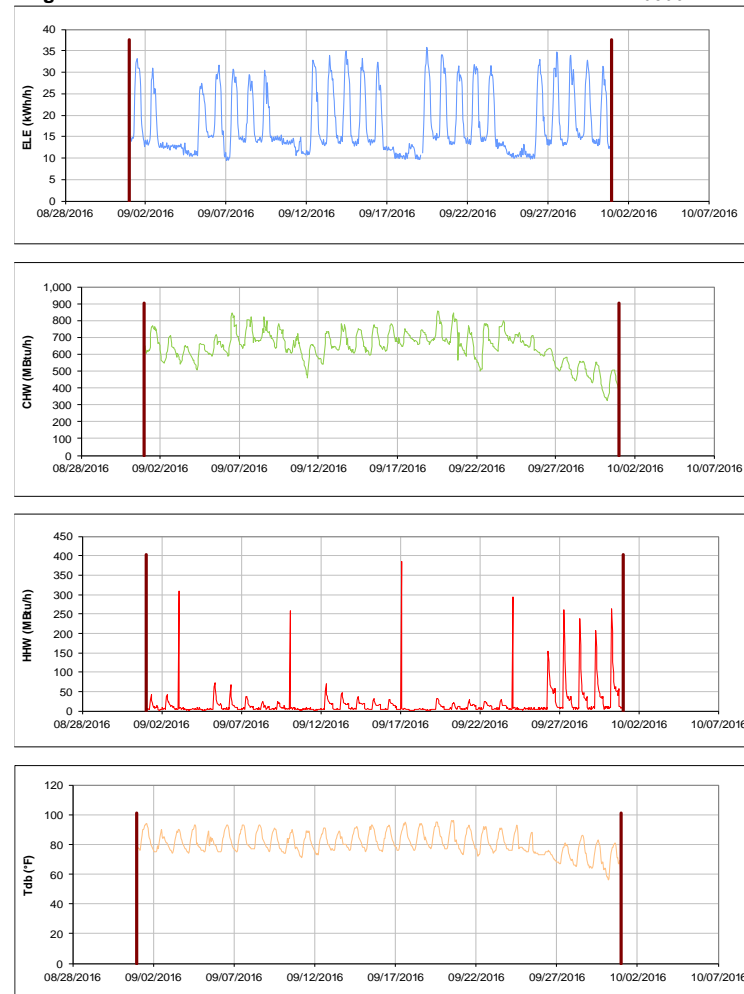
TAMU / BLDG #: 0506

Figure III-102 Hourly Whole Building Electricity, Chilled Water, and Hot Water Consumption for Nagle Hall during the Month of September 2016 and the Corresponding Hourly Outdoor Dry Bulb Temperature for College Station, TX

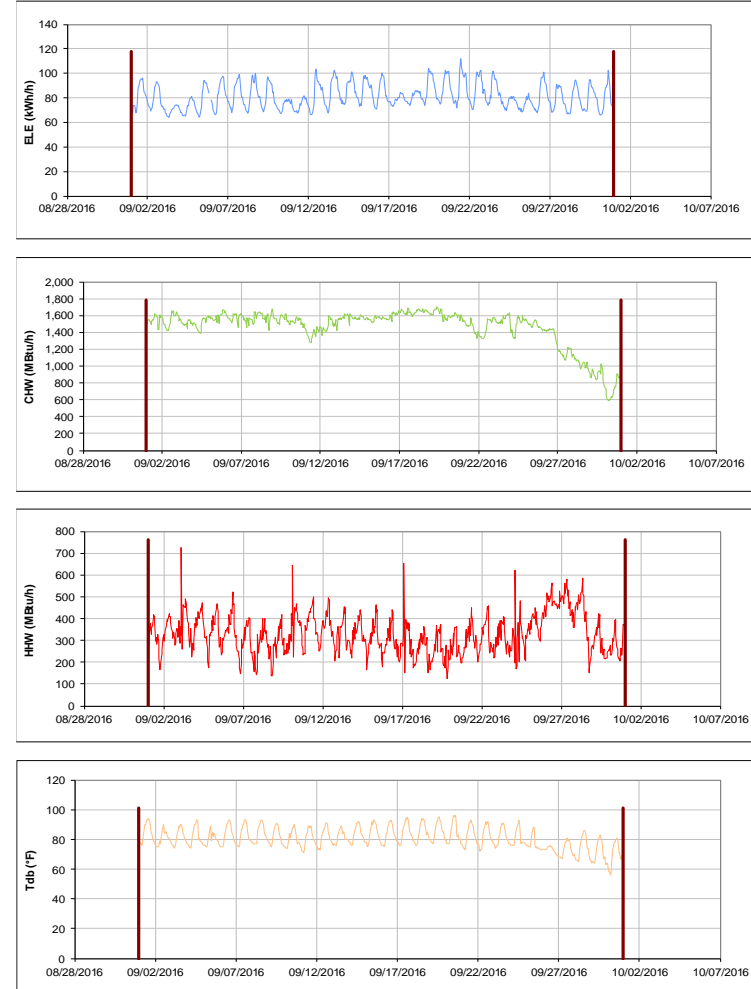
TAMU / BLDG #: 0513

Figure III-108 Hourly Whole Building Electricity, Chilled Water, and Hot Water Consumption for Doherty Building during the Month of September 2016 and the Corresponding Hourly Outdoor Dry Bulb Temperature for College Station, TX

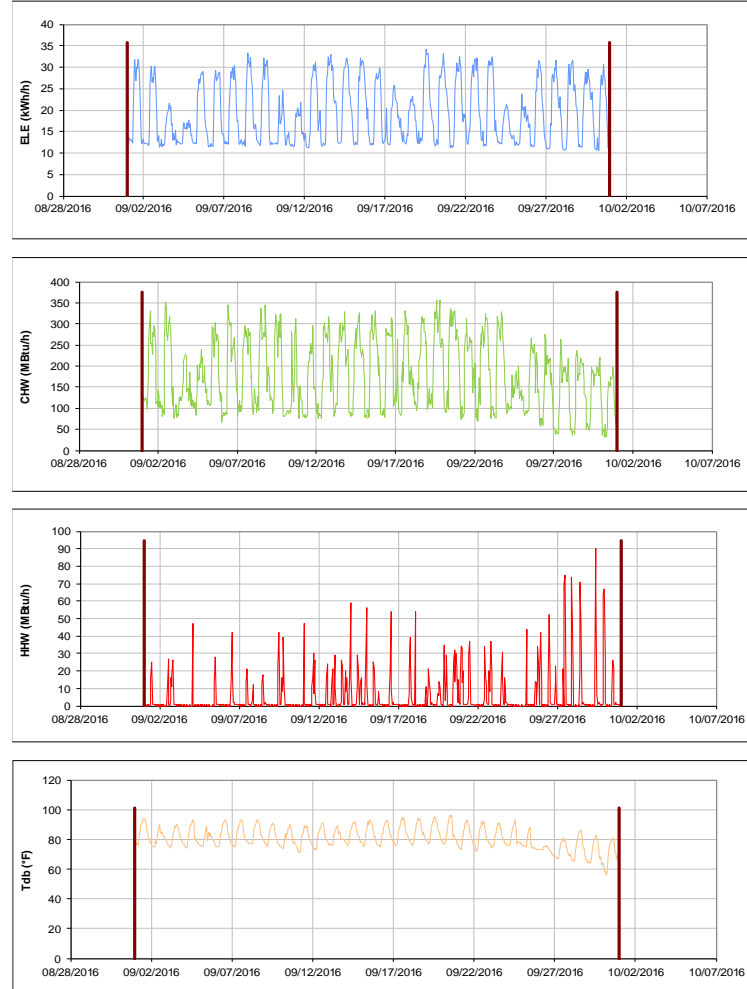
Munnerlyn Astronomy & Space Sciences Engineering TAMU / BLDG #: 0514

Figure III-109 Hourly Whole Building Electricity, Chilled Water, and Hot Water Consumption for Munnerlyn Astronomy & Space Sciences Engineering during the Month of September 2016 and the Corresponding Hourly Outdoor Dry Bulb Temperature for College Station, TX

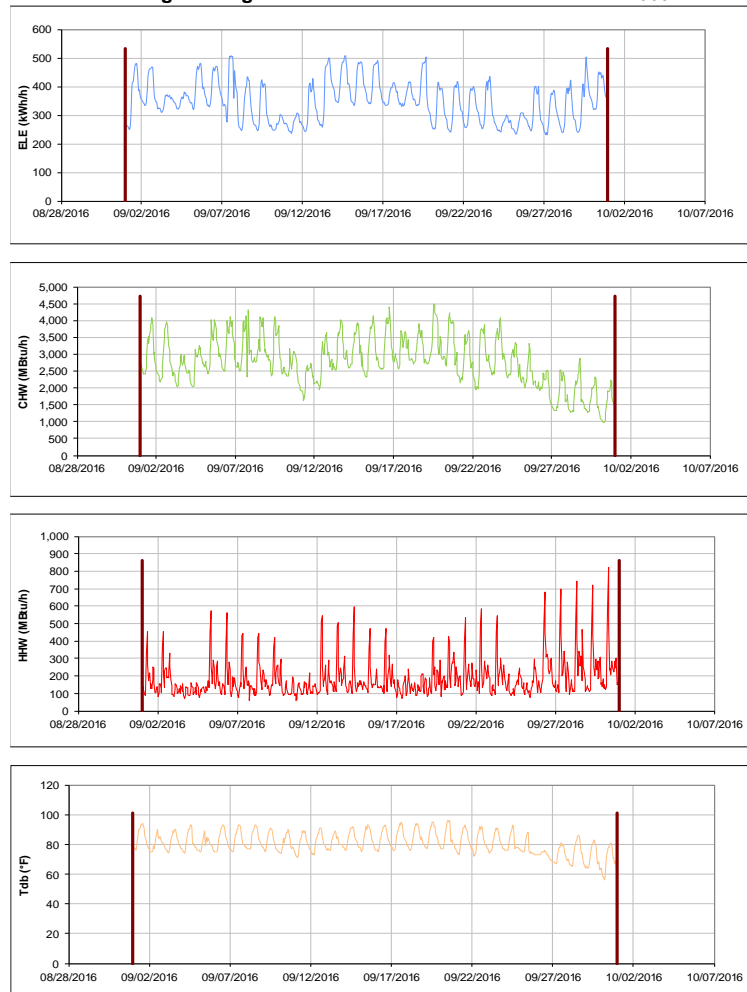
TAMU / BLDG #: 0682

Figure III-119 Hourly Whole Building Electricity, Chilled Water, and Hot Water Consumption for Wisembaker Engineering Research Center during the Month of September 2016 and the Corresponding Hourly Outdoor Dry Bulb Temperature for College Station, TX

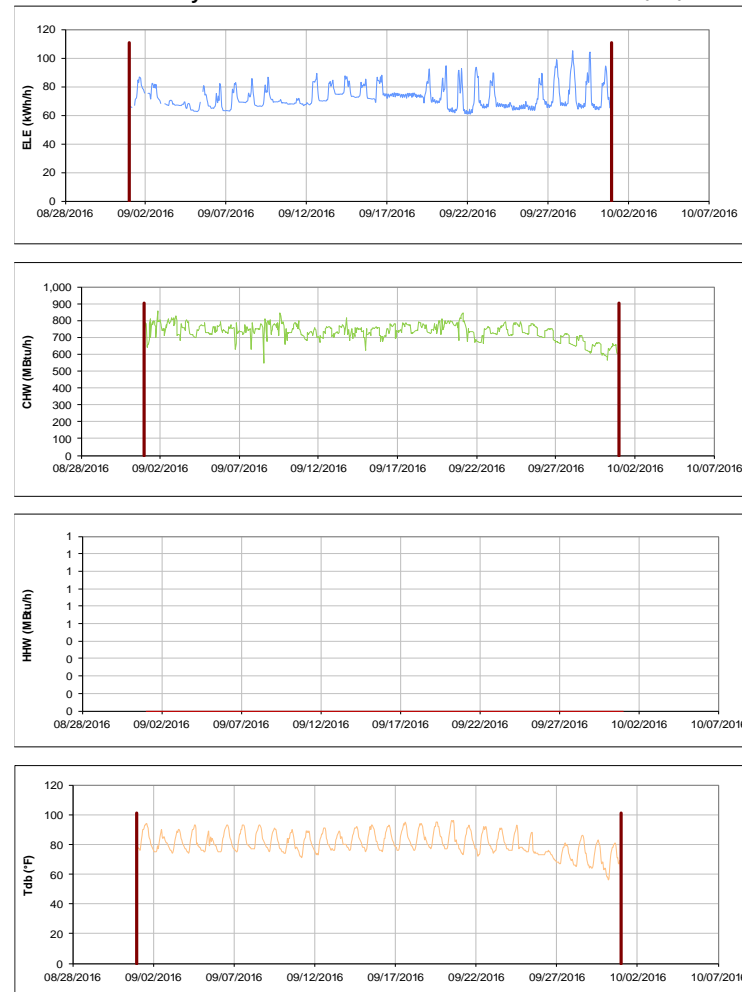
TAMU / BLDG #: 0740

Figure III-120 Hourly Whole Building Electricity, Chilled Water, and Hot Water Consumption for McNew Laboratory during the Month of September 2016 and the Corresponding Hourly Outdoor Dry Bulb Temperature for College Station, TX

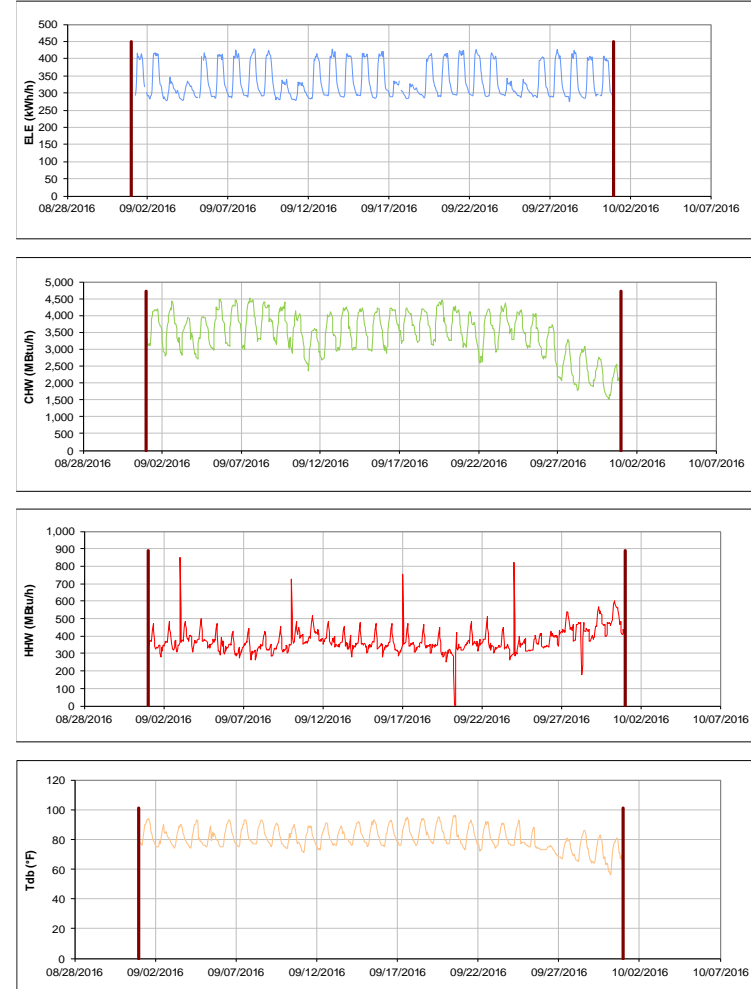
TAMU / BLDG #: 1085

Figure III-128 Hourly Whole Building Electricity, Chilled Water, and Hot Water Consumption for Veterinary Small Animal Hospital during the Month of September 2016 and the Corresponding Hourly Outdoor Dry Bulb Temperature for College Station, TX

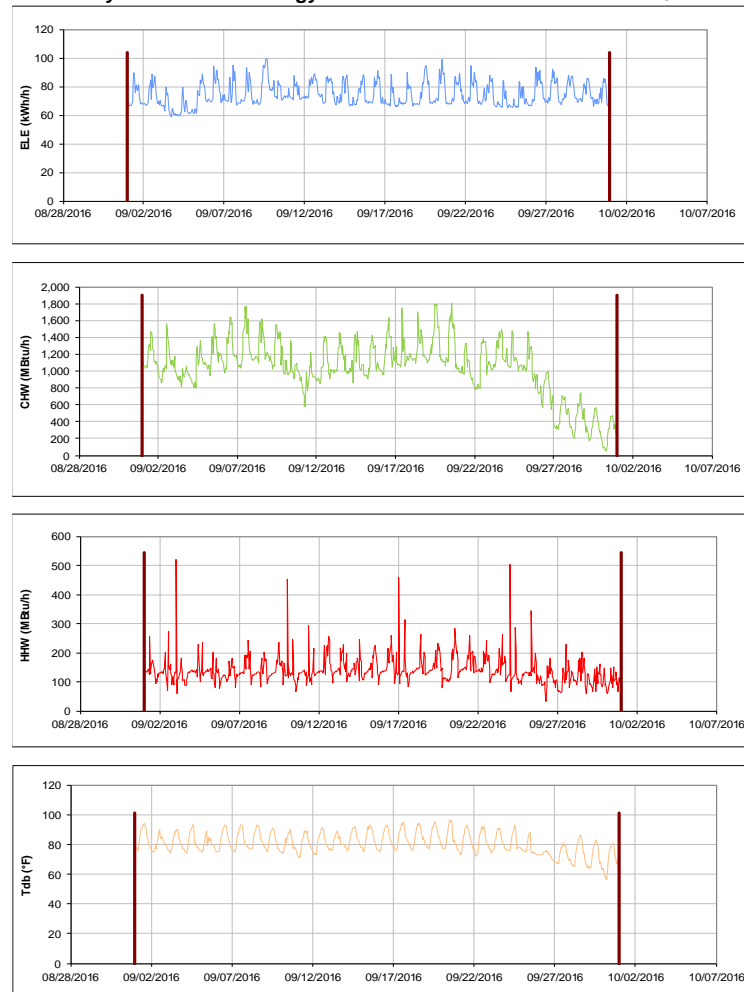
TAMU / BLDG #: 1184

Figure III-132 Hourly Whole Building Electricity, Chilled Water, and Hot Water Consumption for Veterinary Anatomic Pathology during the Month of September 2016 and the Corresponding Hourly Outdoor Dry Bulb Temperature for College Station, TX

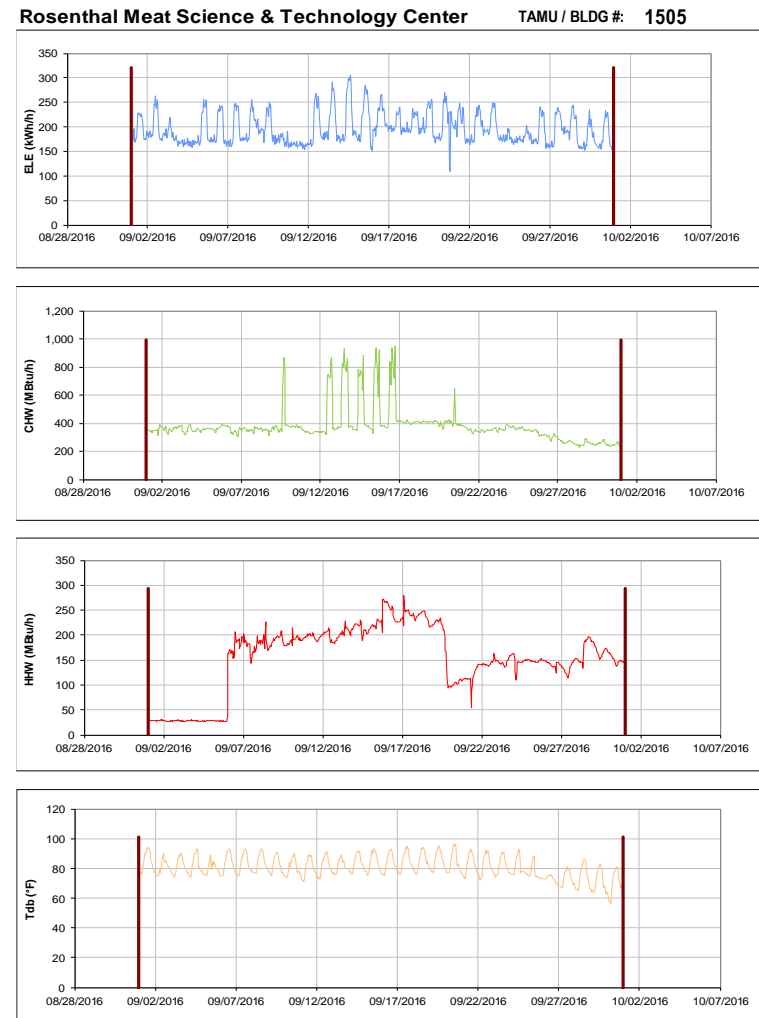
Figure III-152 Hourly Whole Building Electricity, Chilled Water, and Hot Water Consumption for Rosenthal Meat Science & Technology Center during the Month of September 2016 and the Corresponding Hourly Outdoor Dry Bulb Temperature for College Station, TX
